# MUNICIPAL LANDFILL AUDIT REPORT

2021

**LAMBERT DE KLERK**

**Manager: Environmental Affairs**

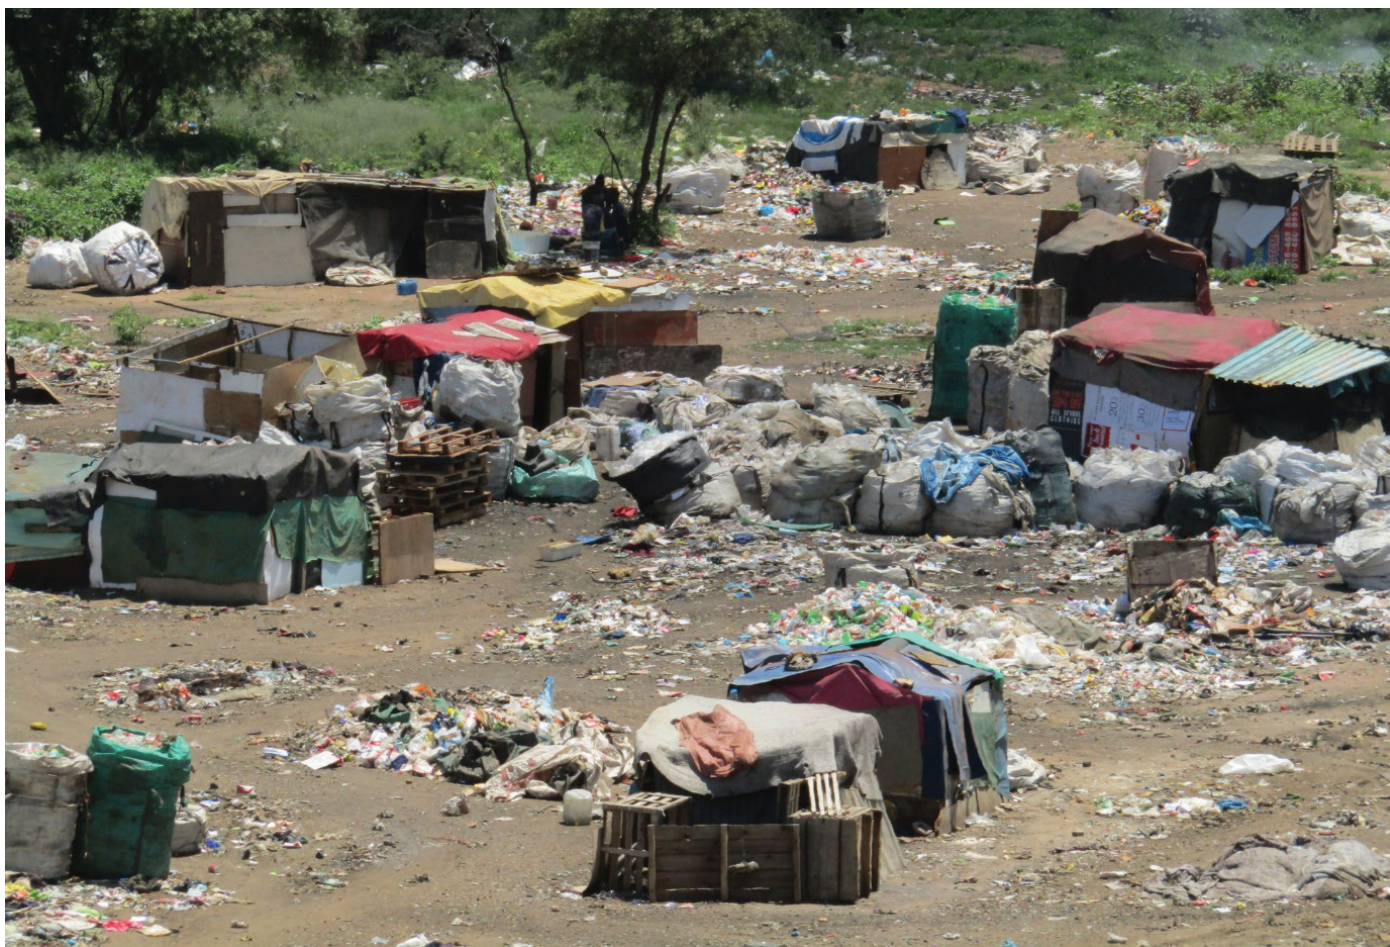
*Shacks in which people live on the Klerksdorp landfill site in the North West*

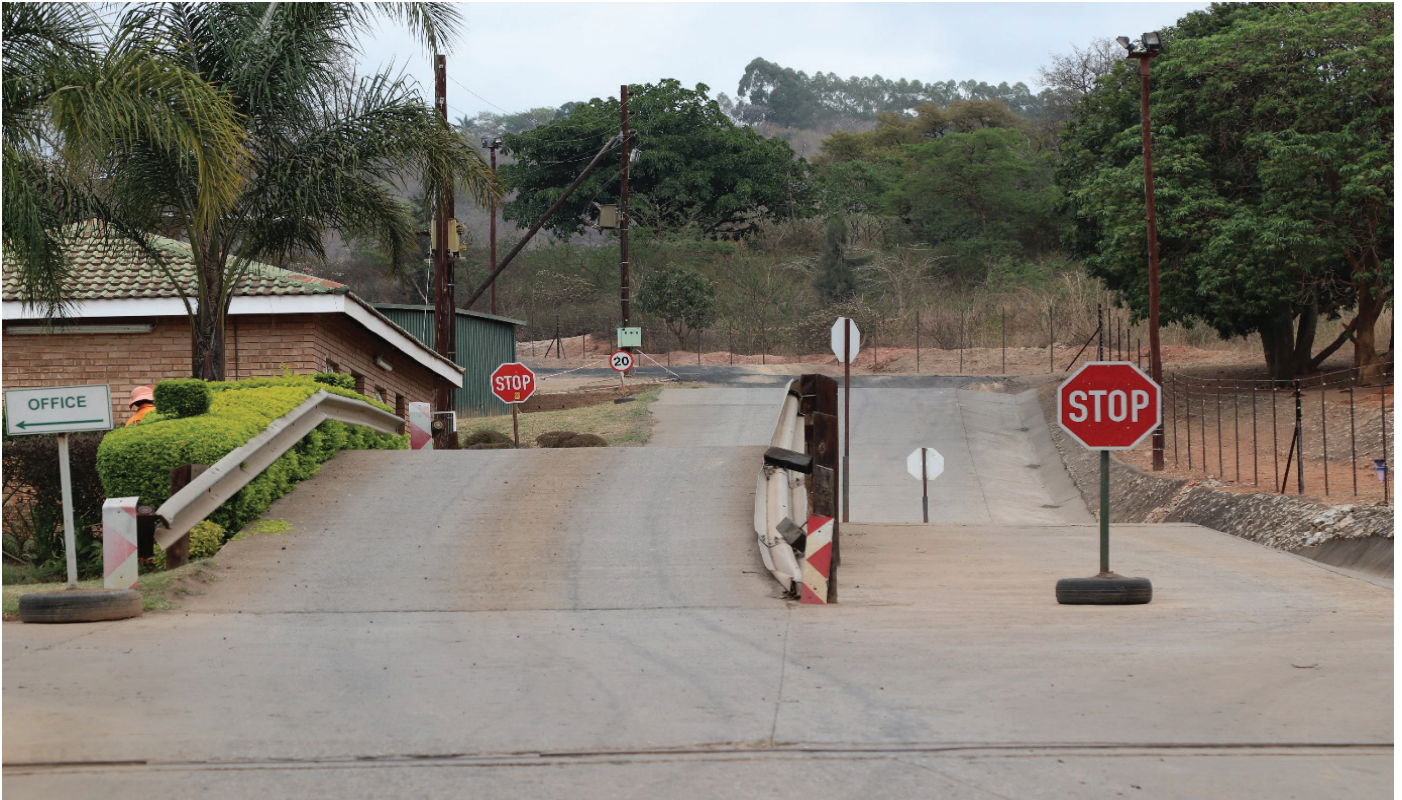
*An impeccable landfill site in Tzaneen, with an operative weighbridge, fence and complete infrastructure*

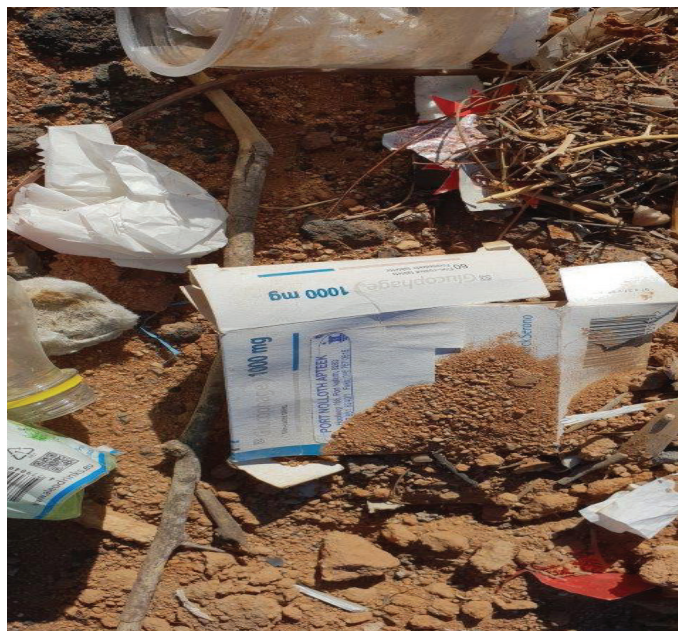
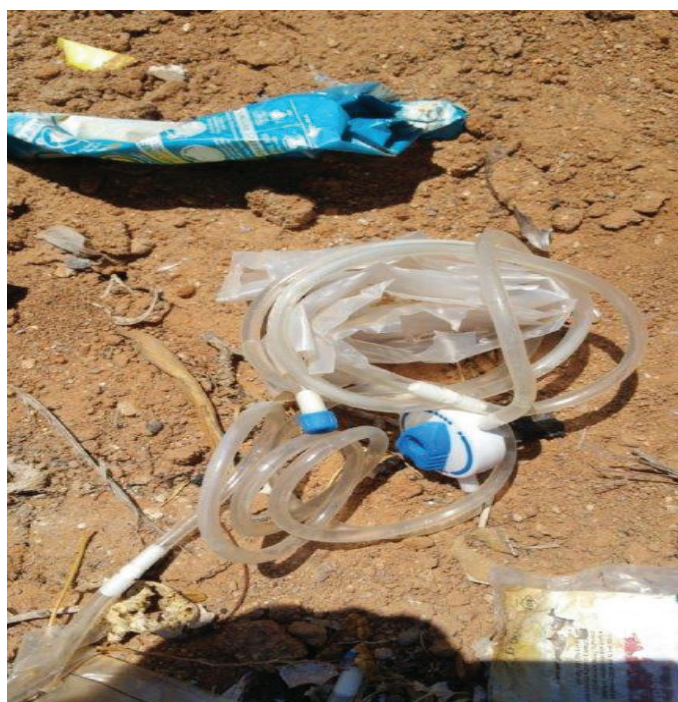
*Hazardous medical waste dumped at the general Springbok landfill site in the Northern Cape.*

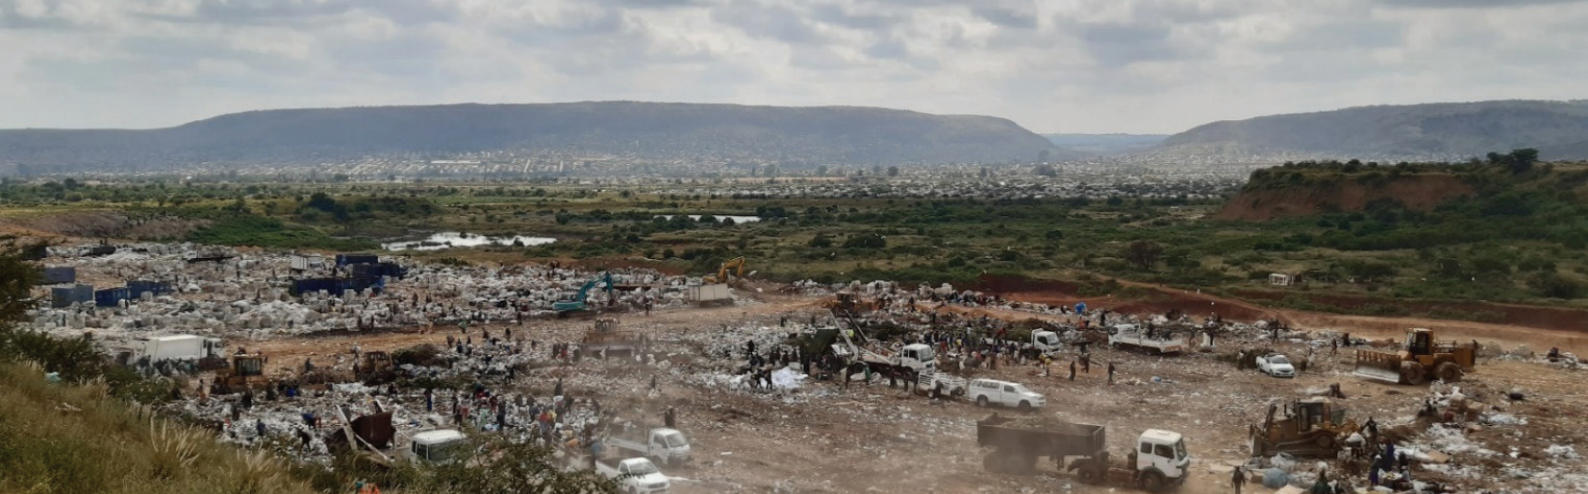
*The Hatherley landfill site, just outside Pretoria in Gauteng*

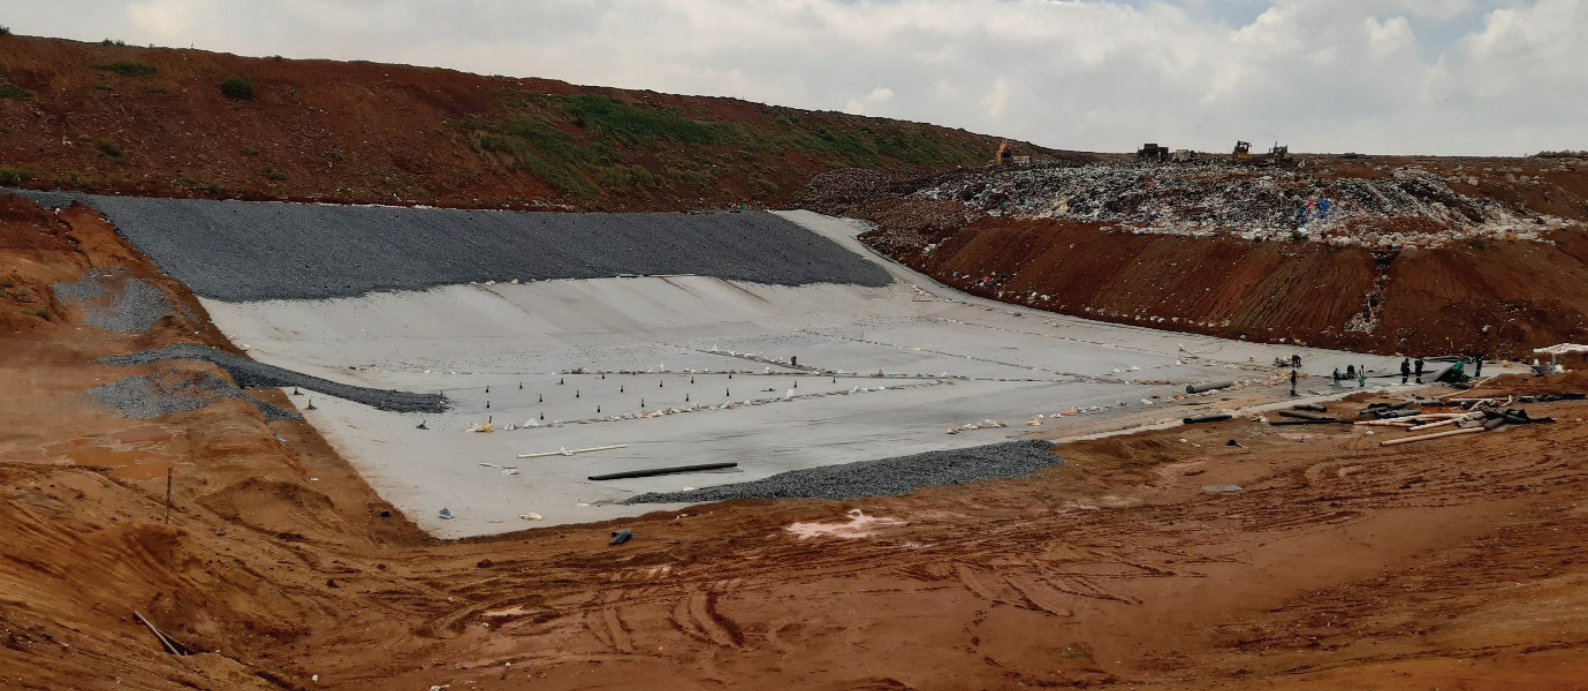
*The Waste Group Class B liner being completed at the Mooiplaas landfill site in Centurion, Gauteng*

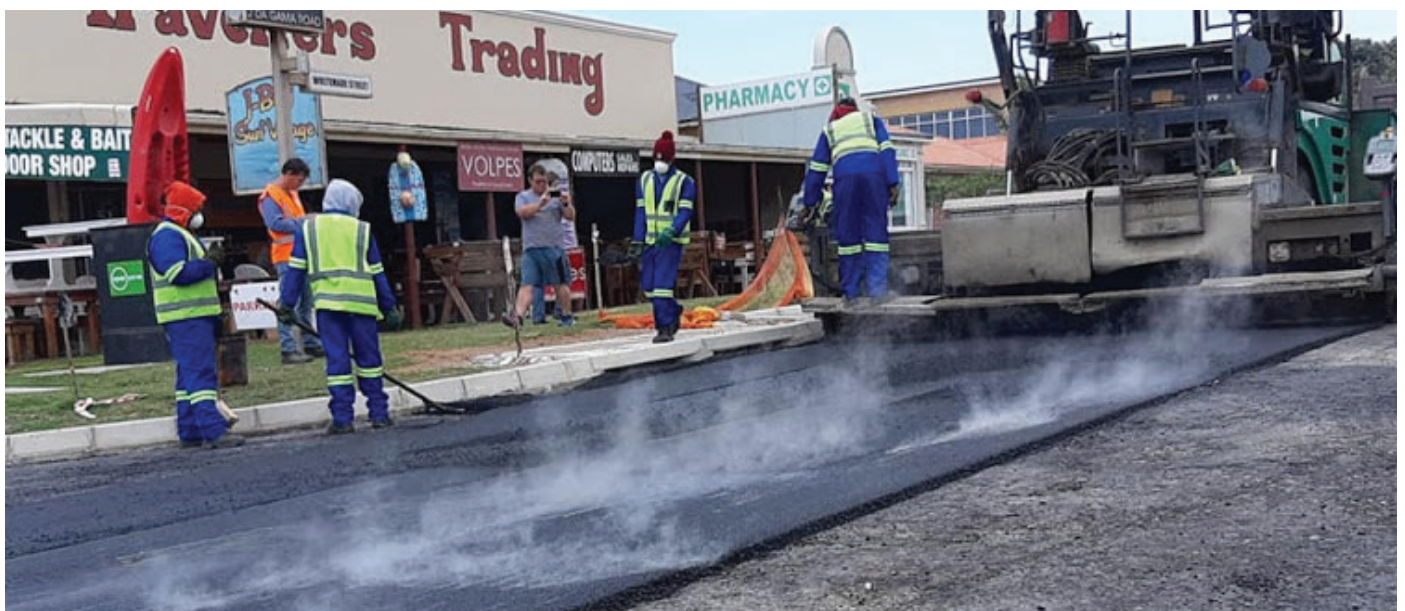
*A street in Jeffreys Bay is repaired by making use of plastic waste*
